EXHIBIT C

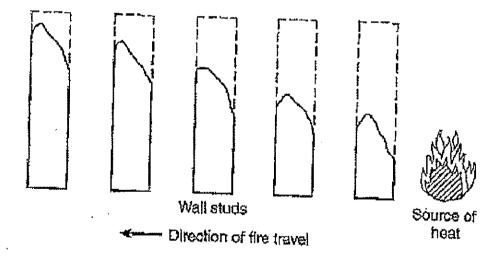
FIGURE 6.17.7 Wood Wall Stude Showing Decreasing Damage as Distance from Fire Increases.
